Figure 4. Figure of Impacted Wildlife Management Area and Sample Locations.

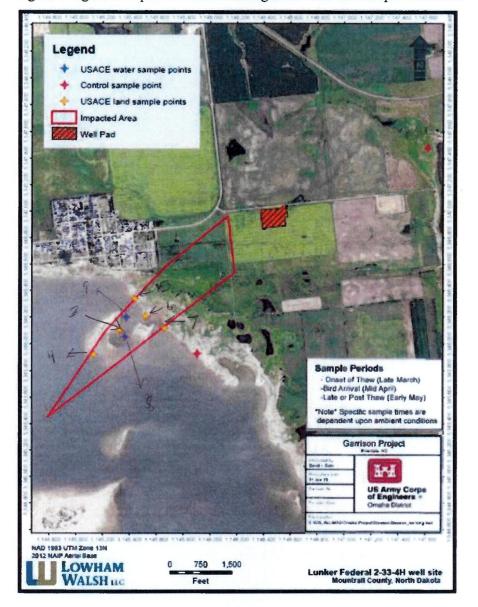
It should be noted that the impacted zone is identified as critical habitat for the Piping Plover, a threatened species, by U.S. Army Corps of Engineers and U.S. Fish and Wildlife Service.
